# Correcting Dynamic Roll Instability

**Low hydrodynamic pressure, or suction, at the forward hull bottom can cause some powerboats to lay over and “stick” at a certain angle of heel at high speed. We consider the causes of the problem, and approaches to fixing it.**

Text and illustrations by  
Donald L. Blount  
and Dean M. Schleicher

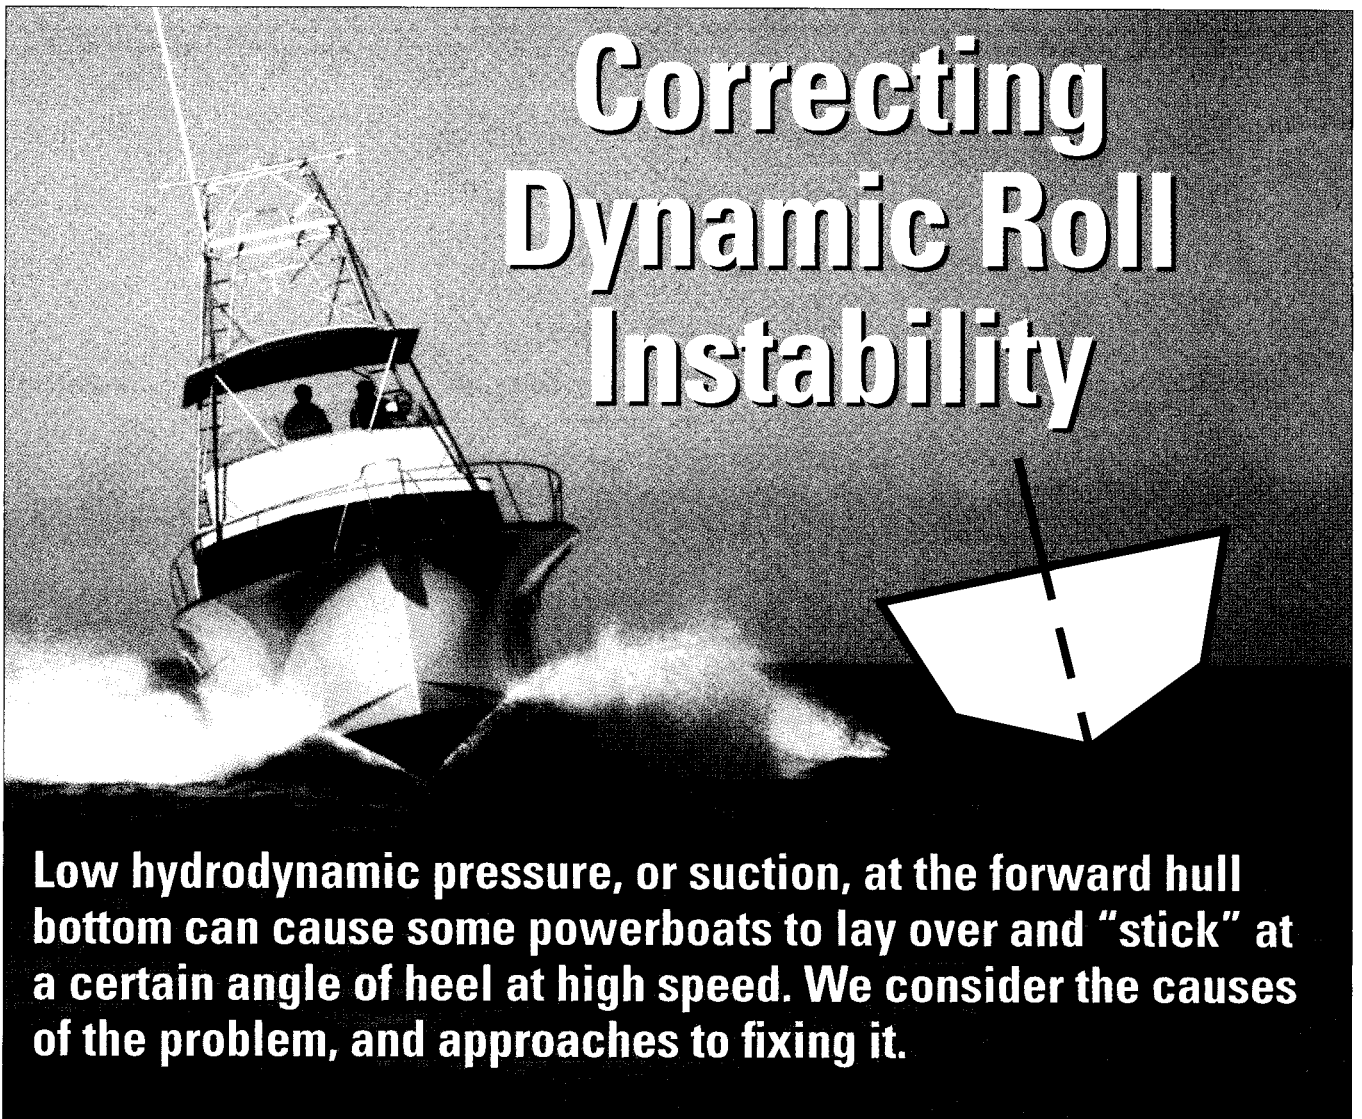
*The 47’ (14.3m) sportfisherman pictured here, underway at 32 knots, will remain heeled until the helmsman takes corrective action—either adjusting rudders or trim tabs, or throttling back until the boat returns to level. A vessel experiencing dynamic roll instability does not continuously cycle in roll, but seeks a new, steady, nonzero angle related to the speed of the boat.*

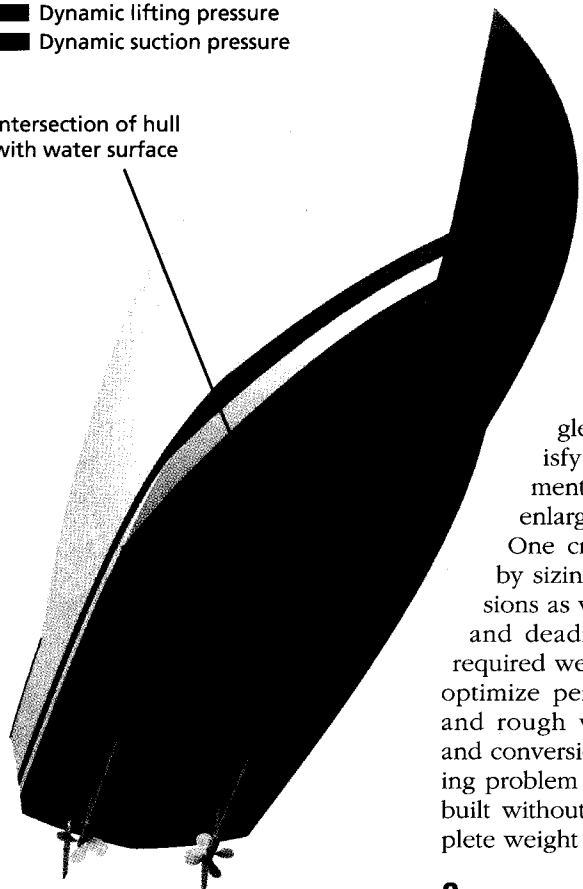
What causes boats to “stick” at a certain angle of heel at high speeds is low hydrodynamic pressure, or suction, on the forward area of the hull bottom (see **Figure 1**). For a quick demonstration of how suction works, hold a spoon loosely in your fingers and touch its rounded bottom surface to water flowing from a faucet. The spoon is sucked into the water, not

**Figure 1**—The arrow in the drawing points to the area of the vessel's bottom where the buttocks curve up. Suction pressures in this region can cause dynamic roll instability.

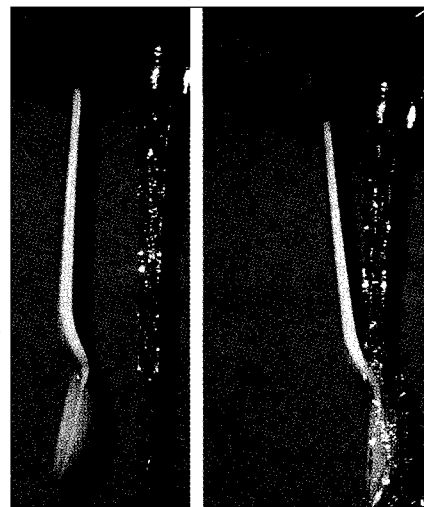
**Figure 2**—For a quick demonstration of how suction works, hold a spoon loosely in your fingers and touch its rounded bottom surface to water flowing from a faucet. The spoon is sucked into the water (**right**), not pushed away.

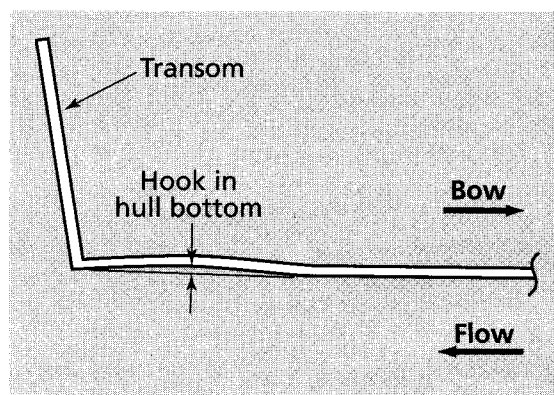
• **Hook in hull bottom near transom.** Bottom hook near the transom (see **Figure 4**) creates dynamic pressures that lift the stern of the hull and reduce the running trim angle—again, leading to the development of suction forward.

**Figure 4**—Bottom hook near the transom creates dynamic pressures that lift the stern and reduce the running-trim angle, causing suction forward. Hook can be unintentionally created during a boat's manufacture—on metal hulls, by plate distortion due to welding; on FRP hulls, by prerelease from the mold.

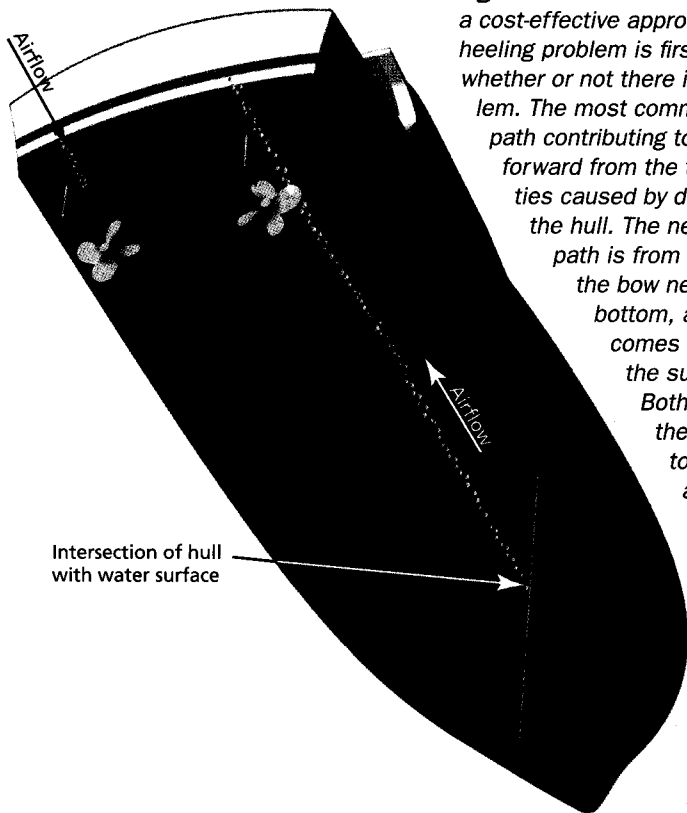
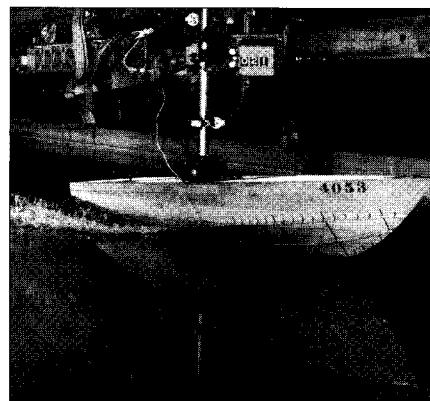
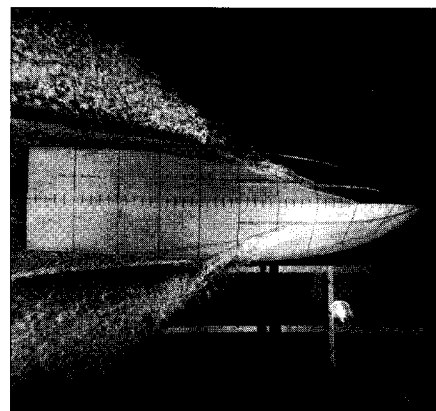
With regard to a heeling problem, the most frequent ventilation air path is flow forward from the transom to fill the cavities caused by disturbances under the hull. In some cases, hull recesses for trim tabs near rudders and/or rudderports facilitate the air path to fill a cavity. The second most frequent air path is from a disturbance at the bow (longitudinal spray strips, transducers, or through-hull fittings) near where the hull bottom, at speed, first comes in contact with the surface of the water. These two ventilation scenarios are illustrated in **Figure 6**. (Although not related to the heeling

**Figure 6**—The authors have found that a cost-effective approach to tackling a heeling problem is first to determine whether or not there is a ventilation problem. The most common ventilation air path contributing to heeling is flow forward from the transom to fill cavities caused by disturbances under the hull. The next most-common path is from a disturbance at the bow near where the hull bottom, at speed, first comes into contact with the surface of the water. Both are illustrated in the drawing. The photos (right), taken in a test tank, show two views of a model with an air path initiated by a spray rail.

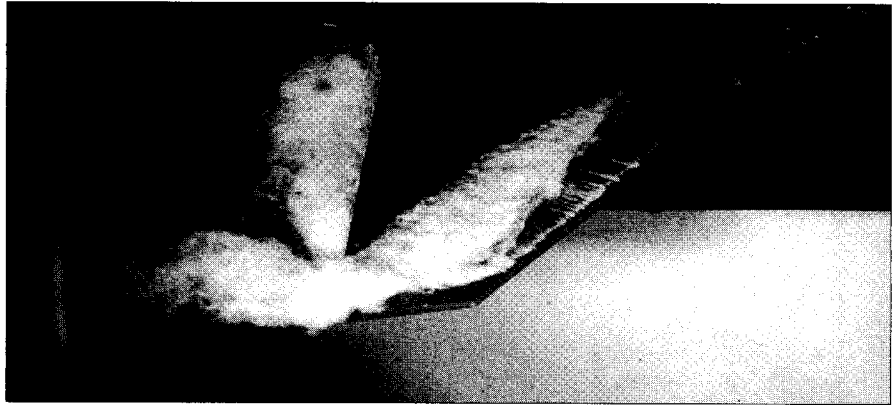
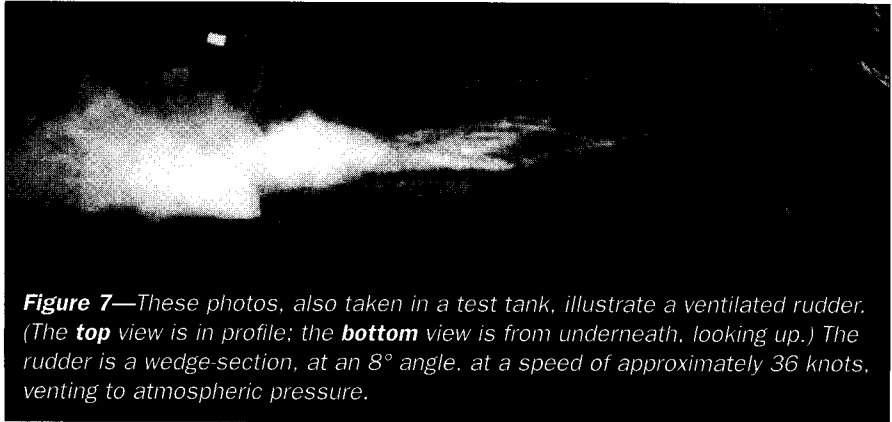
**Figure 7** illustrates a ventilated rudder: a wedge-section rudder at an 8° angle, at a speed of approximately 36 knots, vent-

ing to atmospheric pressure. Flowing air from the top fills the full height of the base cavity; then air flows forward through the tip vortex and up into the cavity on the low-pressure side of the rudder blade.

**Figure 7**—These photos, also taken in a test tank, illustrate a ventilated rudder. (The **top** view is in profile; the **bottom** view is from underneath, looking up.) The rudder is a wedge-section, at an 8° angle, at a speed of approximately 36 knots, venting to atmospheric pressure.

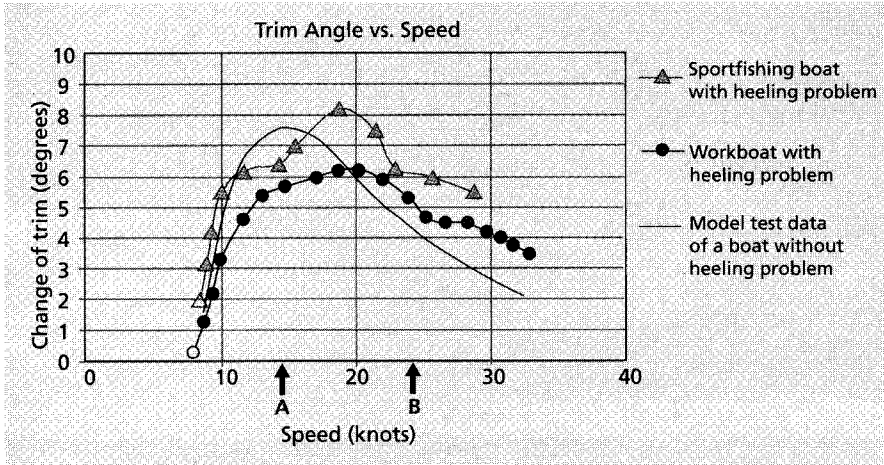
**Figure 8** shows experimental change-of-trim versus speed from sea trials of two different boats of the same size. Both boats were troubled by laying over at speeds above 25 knots. Also included for comparison are model test data for an untroubled boat. Arrows labeled "A" and "B" in the figure point to speeds where there are changes of slope or wiggles in the trim-versus-speed curves for the two troubled boats. (There are no such changes in the slope for the boat without a heeling problem.)

speed lower than that of the maximum trim. That means the forward curved buttocks of the hull are wetted and developing suction, which holds the trim down until increased boat speed creates sufficient dynamic lift to overcome it. Suction development at semi-planing speed forecasts the potential for suction at high speed, pulling the bow down and laying the hull over on its chine.

A second slope change or wiggle in the trim-versus-speed curve may be present at speeds greater than that of maximum trim at hump, as seen in Figure 8 at the region marked by the B arrow. This slope change is likely to result from ventilation of appendages such as a rudderpost or rudder. If this change in slope is seen in the sea trial results, a repeat test is in order, after one of the following steps is taken: rudderposts are cut off flush with the hull; rudders are removed and holes plugged; rudders are dropped away from the hull a distance greater than the post diameter; or a bottom plate extending aft of the transom is added

**Figure 8**—Experimental change-of-trim versus speed from sea trials of two different boats of the same size, both with heeling problems at speeds over 25 knots. A third boat, with no heeling problem, is included for comparison. The arrows point to speeds where there are changes of slope or “wiggles” in the trim-versus-speed curves for the two troubled boats.

to seal off the ventilation path. The change in slope at speeds above that of the maximum hump trim should diminish or disappear if appendage ventilation was in fact the source of the heeling problem.
